THIRD ITEM ON THE AGENDA

Renovation plan of the headquarters building: Review of the independent study and financial plan

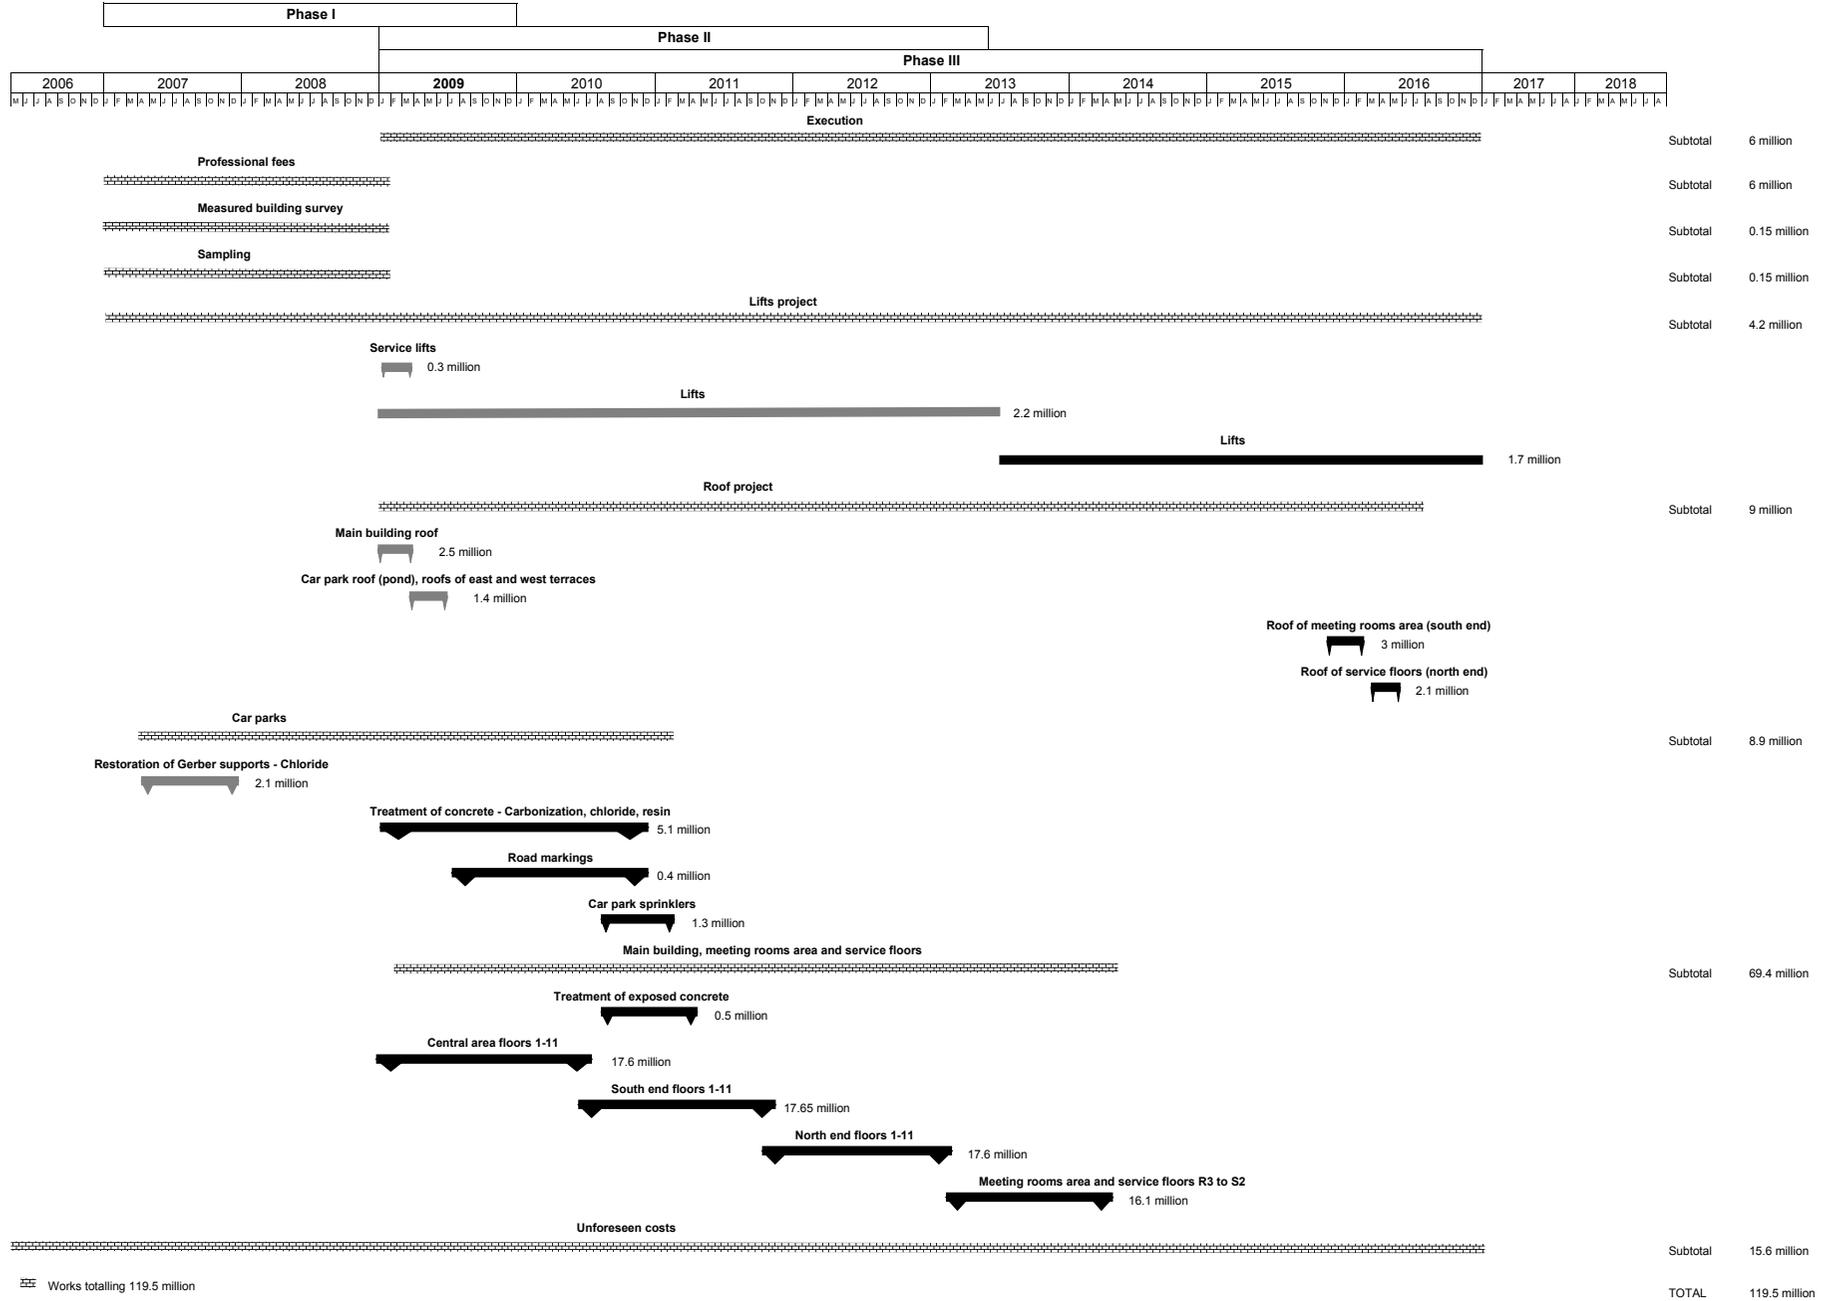
Appendix I

Works totalling 119.5 million

Phases I and II - 8.5 million

Phase III - 83 million
